UNITED STATES
DEPARTMENT OF THE INTERIOR
BUREAU OF RECLAMATION

HYDRAULIC LABORATORY TESTS OF SEALS FOR
HIGH-HEAD COASTER AND FIXED WHEEL
STRUCTURAL STEEL GATES

Hydraulic Laboratory Report No. Hyd. -311

July 20, 1951

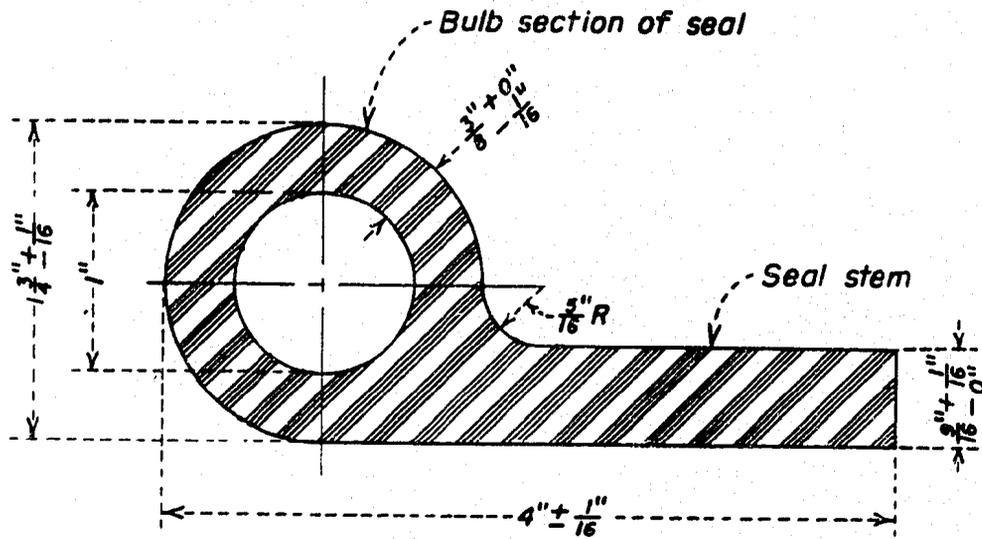
A - HOLLOW BULB SEAL WITHOUT BRASS SHIELD

HIGH HEAD GATE SEAL STUDIES
SECTIONS OF MUSIC NOTE TYPE SEALS

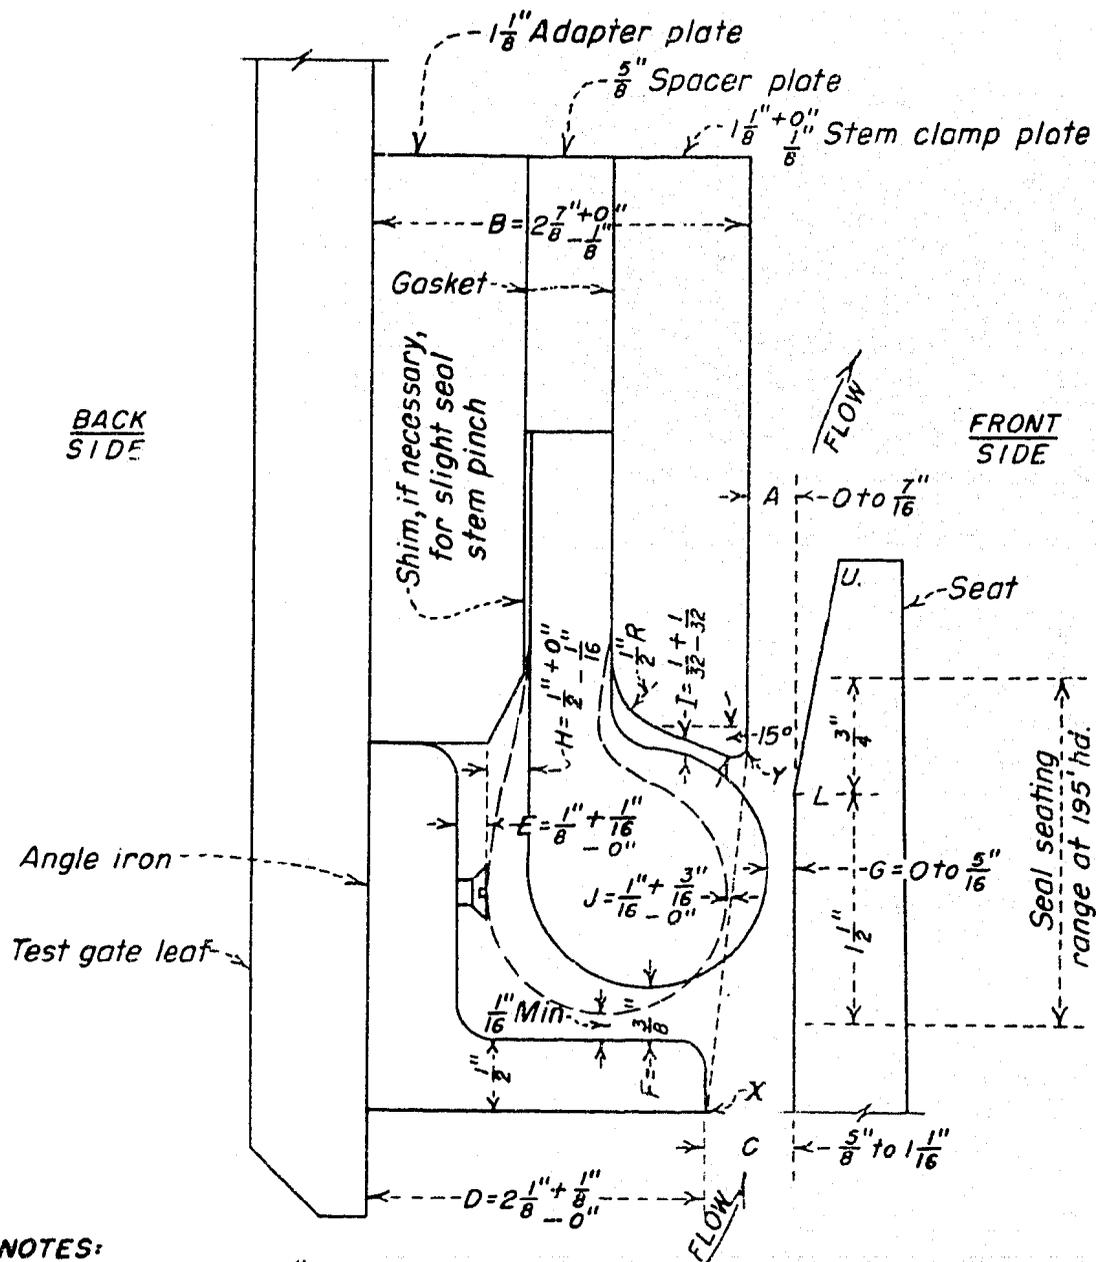
MUSIC NOTE SEAL ASSEMBLY. DIMENSIONS FOR AUTOMATIC RETRACTION AND EXTENSION OF BOTTOM SEAL BULB.

be used together. The latter condition was the case for Figure 38 as the J dimension was nearly zero.

(h) The main effect of water leakage between the ends of the steel parts and the rig windows (not a field condition) and through the stem clamp plate attaching-screw holes was to slightly retard the time of retraction. The accumulated leakage from all sources in the field gates into this area behind the bulb must be kept below some unknown leakage that would prevent retraction of the bulb. Also, if this leakage is high, it will slightly advance the time when the stem clamp plate control becomes effective. Further, the bulb will not seal (extend) if the leakage from behind the bulb is high; for example, the leakage that may occur past the back side of the seal stem and out the spacer bar parting surfaces. Ordinary sealing precautions in the assembly of the seal and gate parts should eliminate the leakages described. It is recommended that a suitable gasket be used on both sides of the spacer bar near each seal stem (Figure 38).

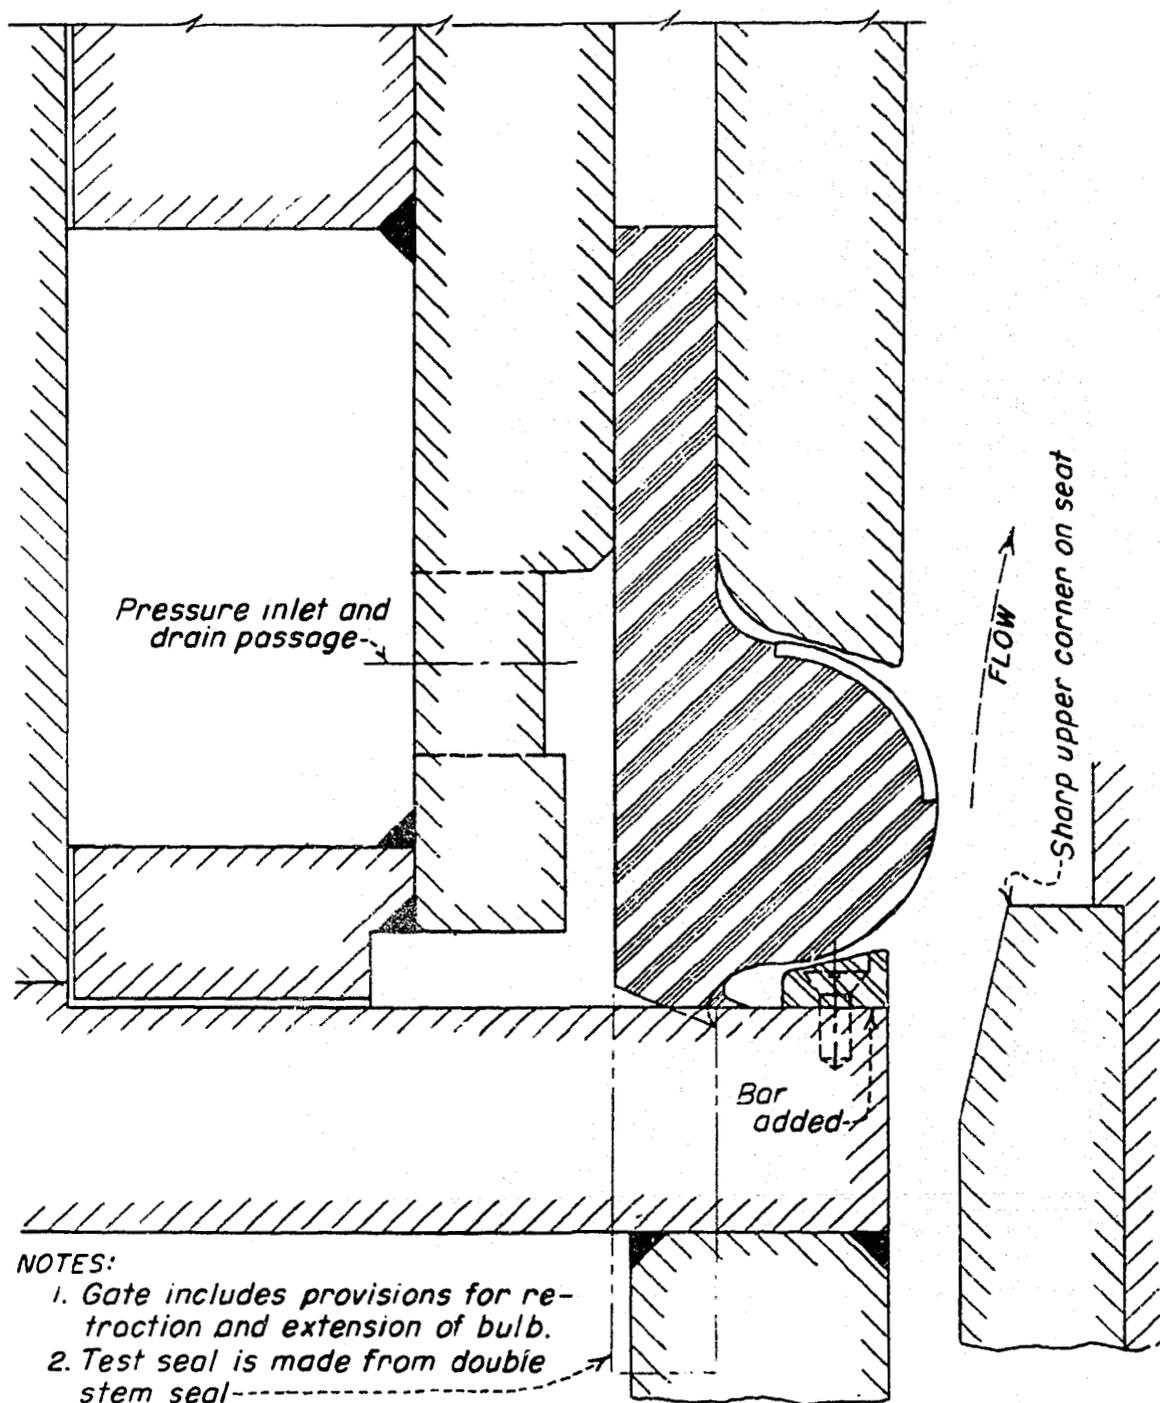
The seal bulb remained extended above 97 feet of head because water leaked through the four $7/16$ " diameter spacer pin holes in the thin rubber bolted section, point "A". These holes were stretched to an elliptical shape. When bulb retraction was attempted, the pressure behind the bulb could not be reduced sufficiently for retraction. Similar leakage is likely to occur through cap-screw holes.

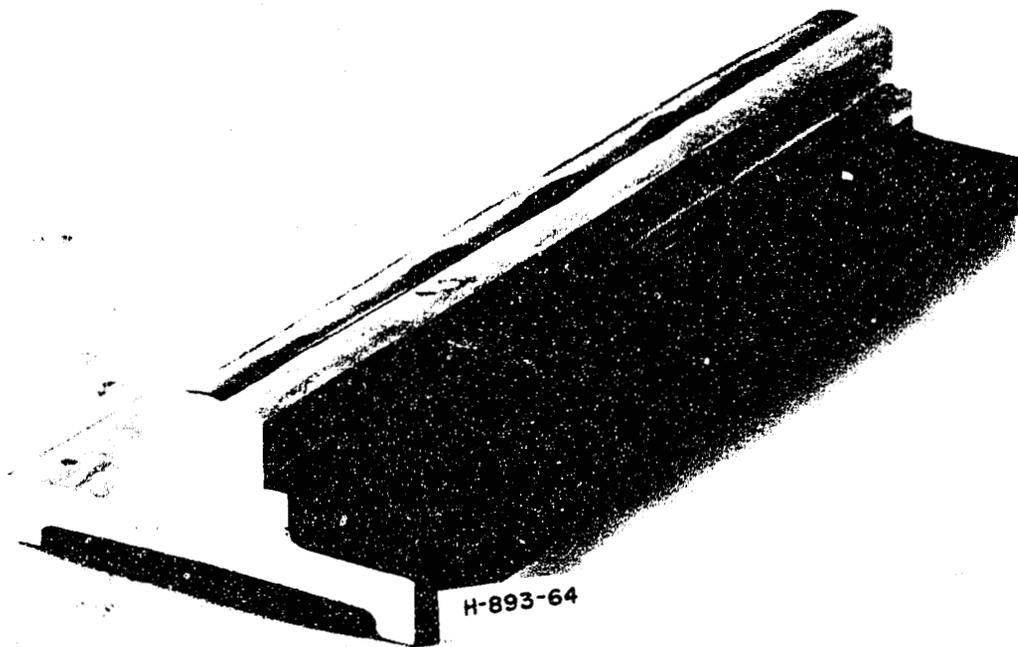
A. Twelve-inch test section of seal. End painted white.

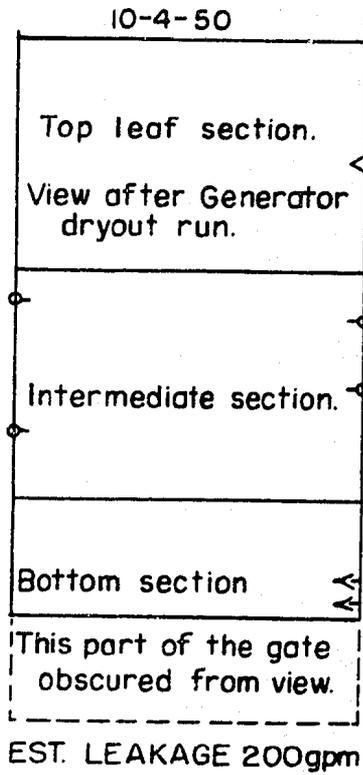
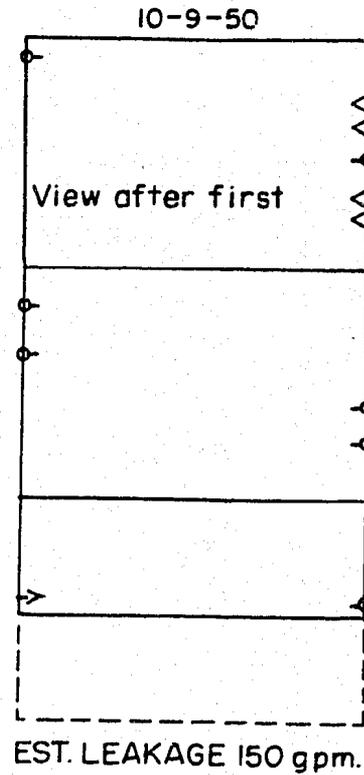
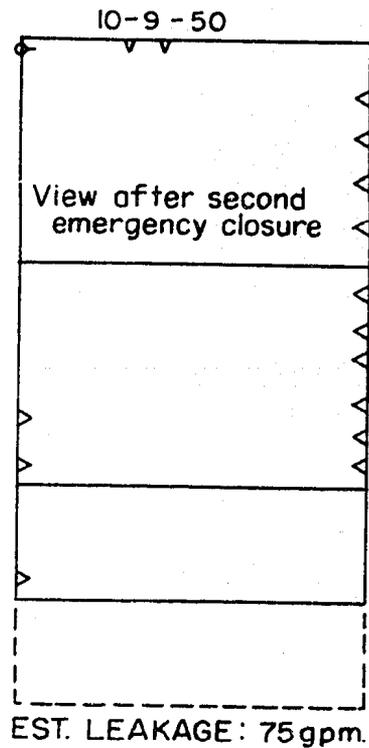
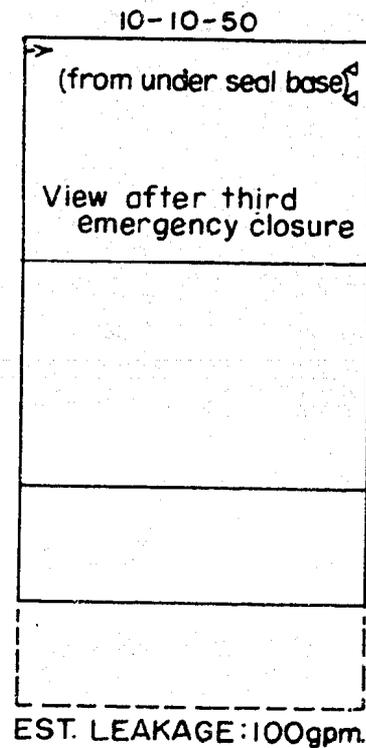
FIGURE 6

An inspection was made of the coaster gate leakage after completion of the dryout run. The seal was obtained by closing the wicket gates, lowering the coaster gate, and opening the penstock drain valve. Leakage past the seals was estimated to be 200 gallons per minute at this time with several leaks apparent. (See figure 6.)

1. The first emergency shutdown was made on October 9, 1950. Inspection of the coaster gate was made shortly after the shutdown and revealed several small leaks past the seals. (See figure 6.) Leakage was estimated to be 150 gallons per minute.
2. The second emergency shutdown was also made on October 9, 1950. Inspection of the gate this time revealed a number of quite small leaks. (See Figure 6.) Leakage was estimated to be 75 gallons per minute.
3. The third emergency closure was made on October 10, 1950. The leakage this time was limited to one large leak near the top of the left vertical seal and a small amount of water coming in under the inner clamp bar on the opposite side. (See Figure 6.) Leakage was estimated to be 100 gallons per minute.

R-6 COASTER GATE LEAKAGE
